After '93

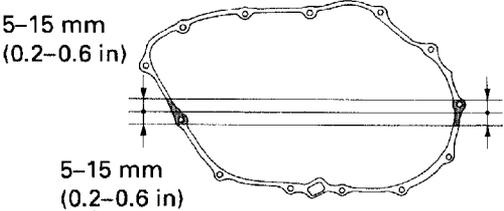
<p>Right crankcase cover gasket surfaces of the crankcase</p>

<p>Liquid sealant</p>	<p>Apply to the area as shown.</p> <p>Apply to the area as shown.</p> <p>Apply to the area shown.</p> <p>Do not apply sealant to the thread head as shown.</p>	
<p>Semicircular portions of the cylinder head Alternator wire grommet seating surface Thermosensor threads</p>	<p>Sealant</p>	<p>Do not apply sealant to the sensor head.</p>
