FRONT WHEEL/SUSPENSION/STEERING

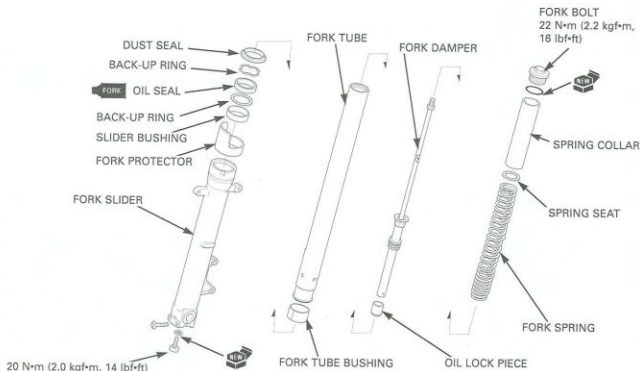
Fork tube bushing

Visually inspect the slider and fork tube bushings. Replace the bushings if there is excessive scoring or scratching, or if the teflon is worn so that the copper surface appears on more than 3/4 of the entire surface.

Check the back-up ring; replace it if there is any distortion at the points shown.
